FHWA/IN/JTRP-99/4

Final Report

**EMBANKMENT WIDENING DESIGN GUIDELINES
AND CONSTRUCTION PROCEDURES**

September 1999

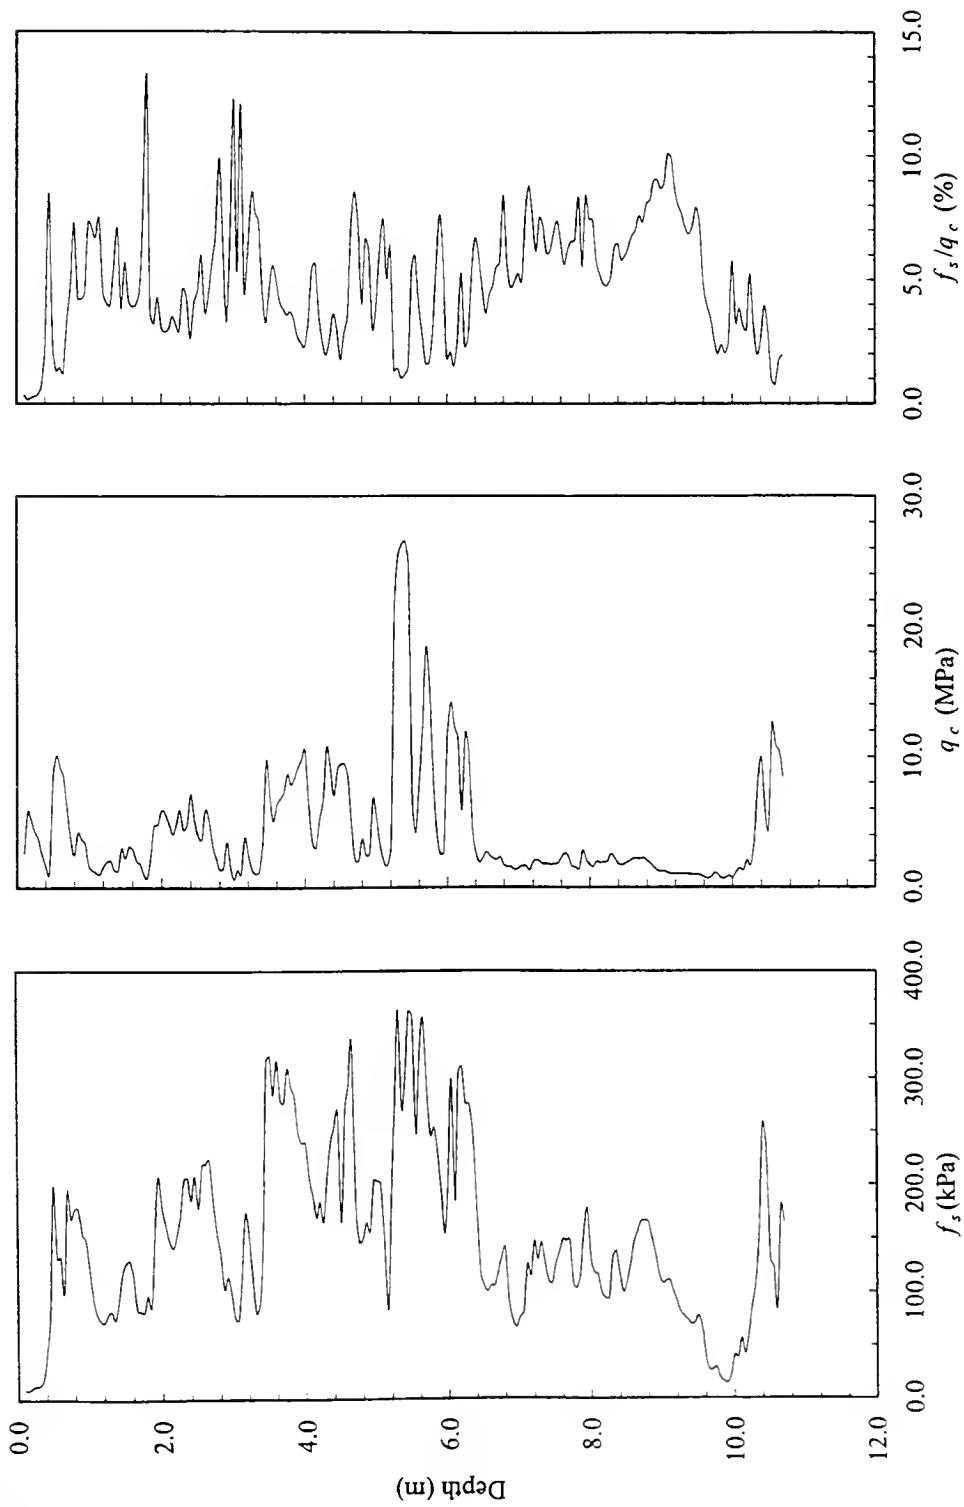
Figure 4.5. Cone penetrometer test data, CPT-710, Sta. 18+874, O.S. 23.48m lt., I-69, Madison County, Greenfield District.

Two cone penetration tests (CPT) were performed at this project site by Purdue University. CPT data are presented in Figure 4.5 and Figure 4.6. The tests were performed adjacent to the shoulder of the highway, offset approximately 6 feet from the edge of pavement. CPTs were performed to evaluate the consistency of the embankment. CPT provides a continuous profile of sub-surface stratigraphy; therefore, it is a superb tool for identifying soft zones or other discontinuities in natural and man-made deposits. No apparent weak zones or discontinuities were identified at the locations of the CPTs.

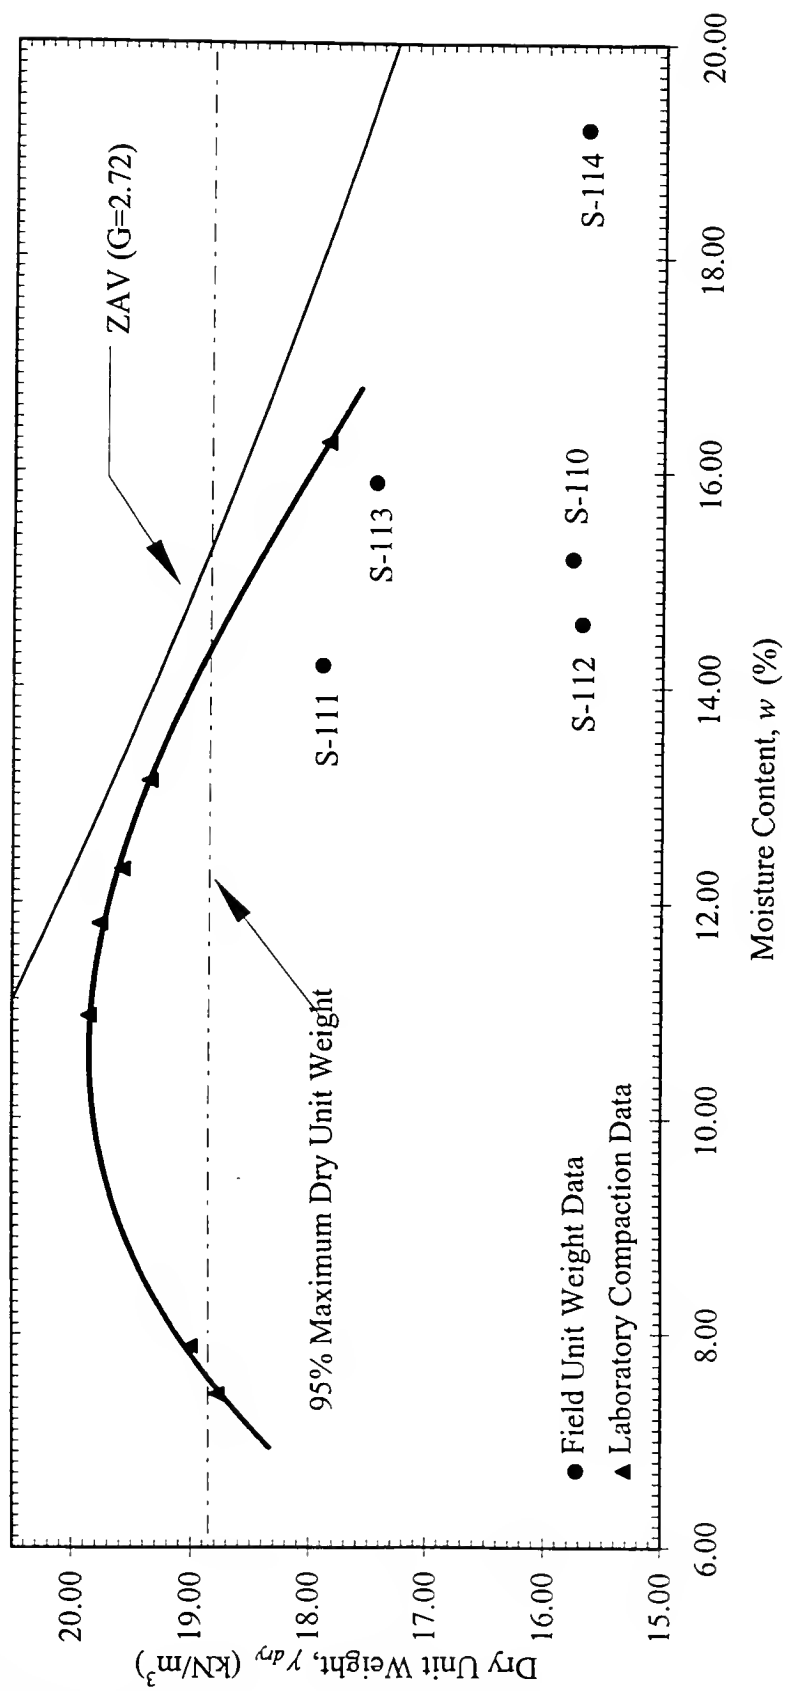
Figure 4.7. Standard Proctor test data and sand-cone data, I-69, Madison County, Greenfield District.

As indicated in Table 4.4, the maximum dry density determined from standard Proctor tests ranged from 1,925 to 2,024 kg/m^3 , and the optimum moisture content ranged from 10.5 to 13.3 percent. Sand-cone tests indicate that relative compaction of the fill used to widen the embankment ranged from approximately 79 to 90 percent. In addition, the moisture contents determined for the field density tests indicate that the soils ranged

from 3.7 to 8.7 percent wet of optimum. These data and the moisture density relationship are presented in Figure 4.7.

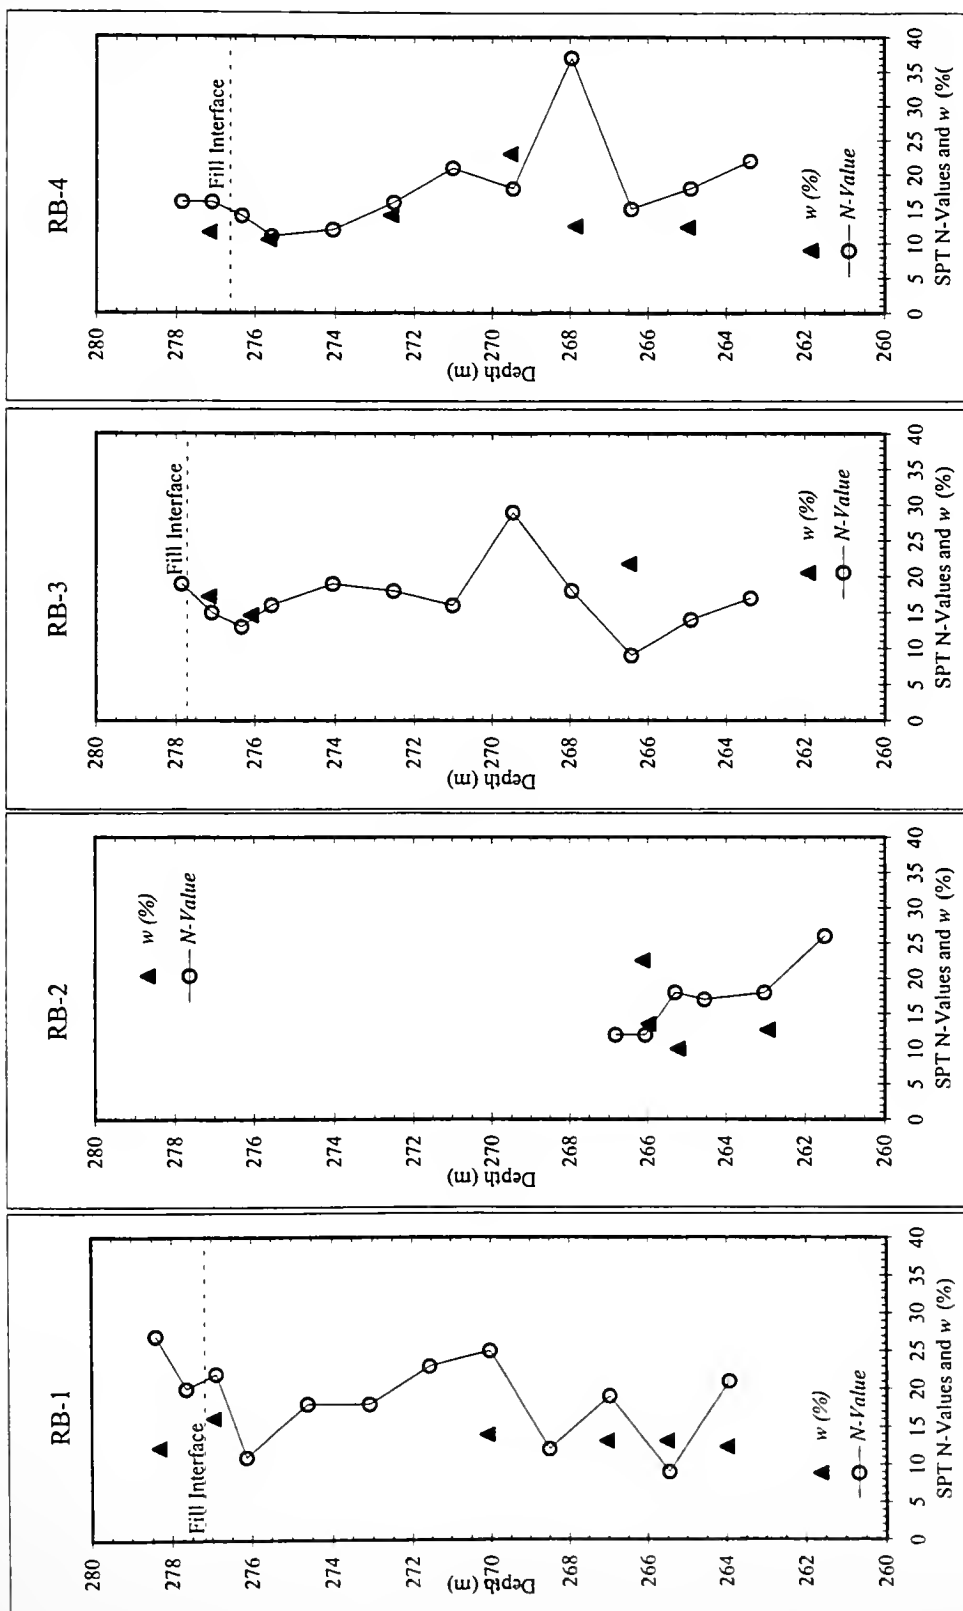
Figure 4.11. Standard penetration test data and water content profiles, I-69, Grant County, Fort Wayne District.

Four borings were advanced by INDOT subsequent to failure. SPT and moisture content profiles are presented in Figure 4.11. RB-1, RB-3 and RB-4 were advanced through the embankment. RB-2 was advanced at the toe of the embankment. The maximum estimated depth of the fill ($\approx 1.83\text{m}$) based on sideslope geometry is presented on the profiles; however, observations made in test pits indicate that the depth to original

ground was shallower. The borings indicate that the consistency of the soil comprising the embankment and foundation is stiff to very stiff. No weak zones indicative of a rupture zone were noted.

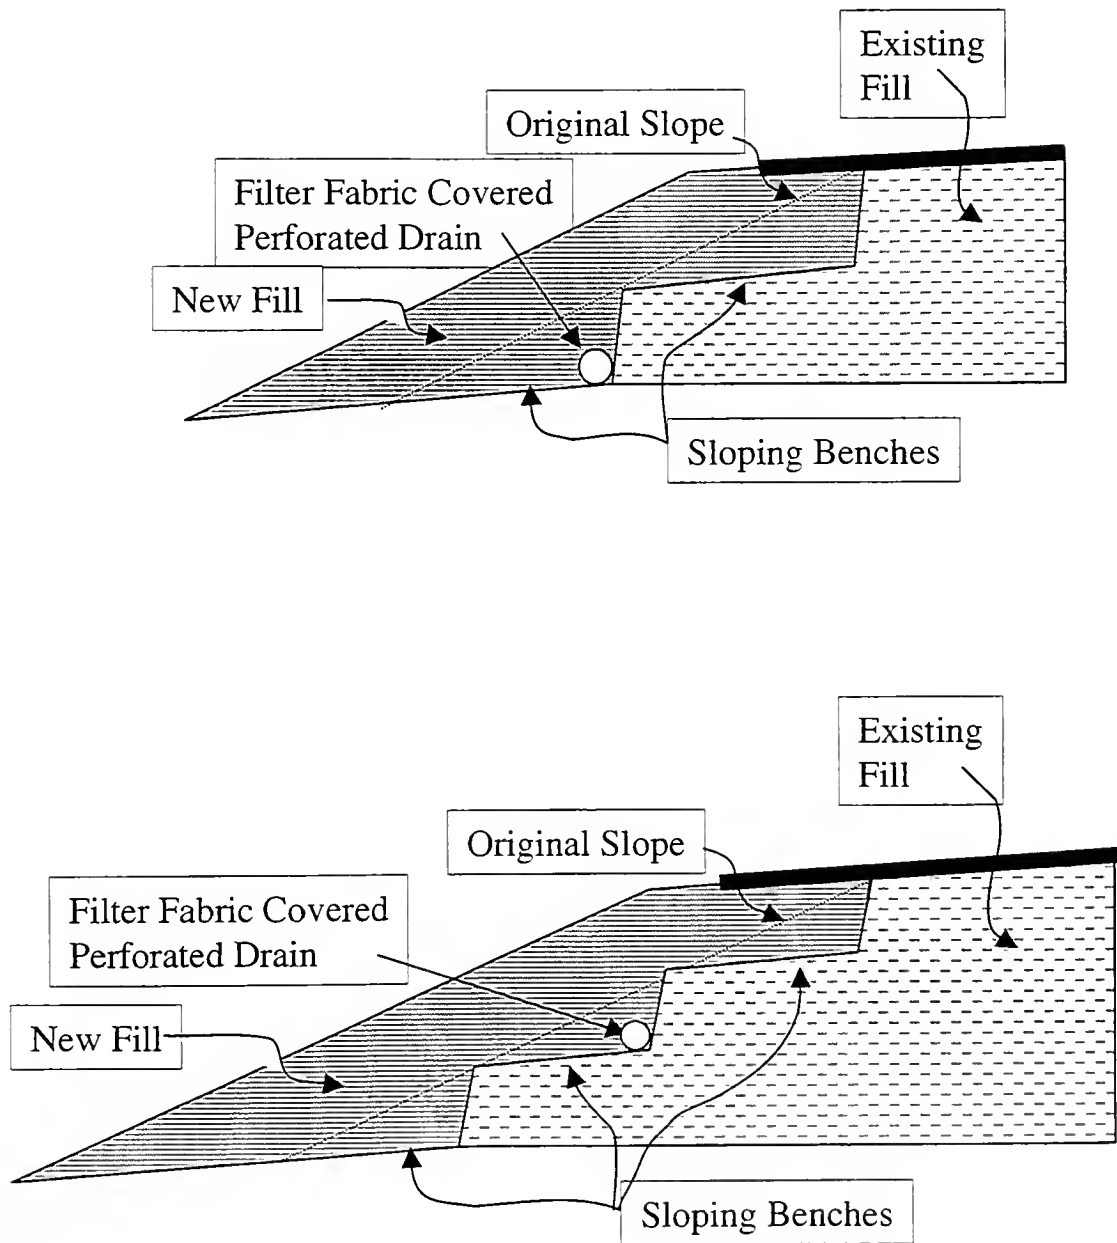
Figure 5.1. Schematics of bench inclination and drain placement illustrating drain located along vertical cut on first bench outside of pavement edge.

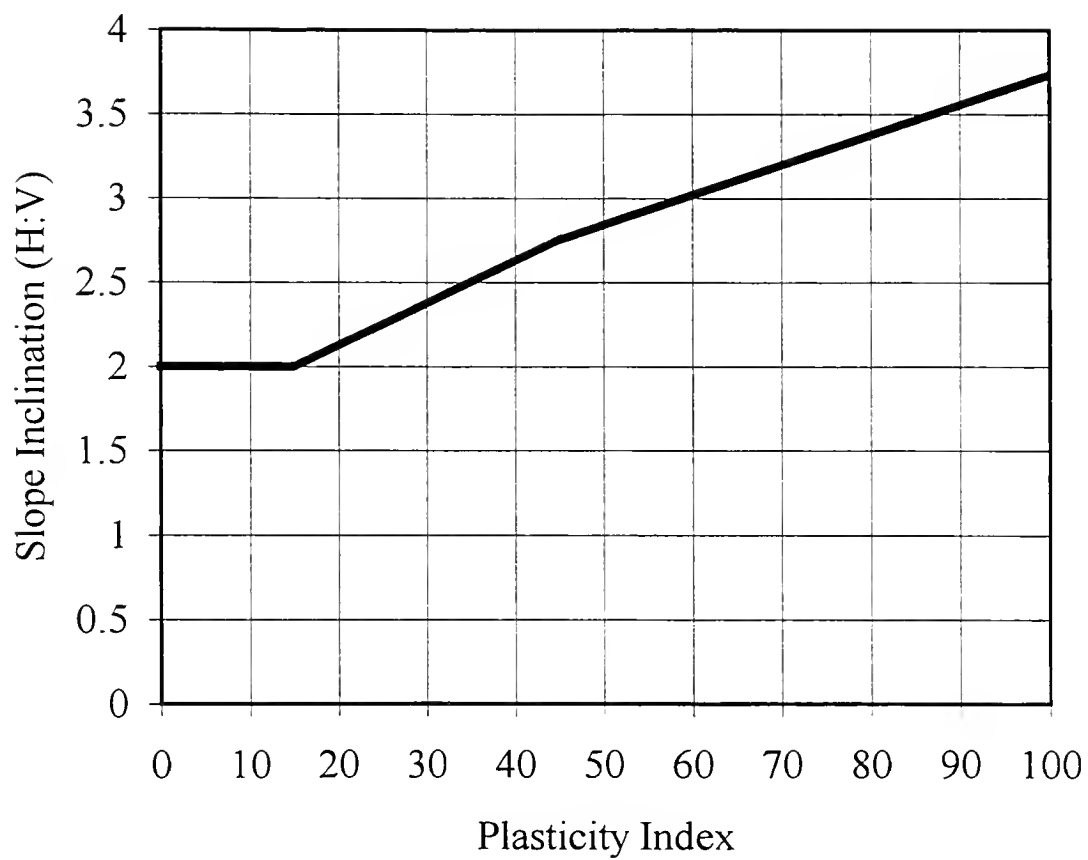
Figure 5.2 Recommended slope inclination as a function of plasticity

The data from Mitchell (1974) were used to develop a simple relationship between plasticity index and slope inclination that is recommended for soils otherwise compacted according to the INDOT *Standard Specifications*. The relationship is provided in both graphical (Figure 5.2) and tabular (Table 5.1) formats. These recommendations were developed assuming prompt development of vegetative cover and controlled transmission of surface water runoff. Moreover, the slope inclinations

recommended are not applicable if there is a potential for groundwater movements within the embankment. It is believed that steeper slopes than those recommended here may be adequate at some sites, however, this would require documentation from a detailed stability analysis using appropriate strength parameters for the specific embankment soils that will be used in construction.
